Track geometry degradation in Swedish heavy haul railroad

Iman Arasteh-khouy, LTU

Research Purpose

Case Study Background

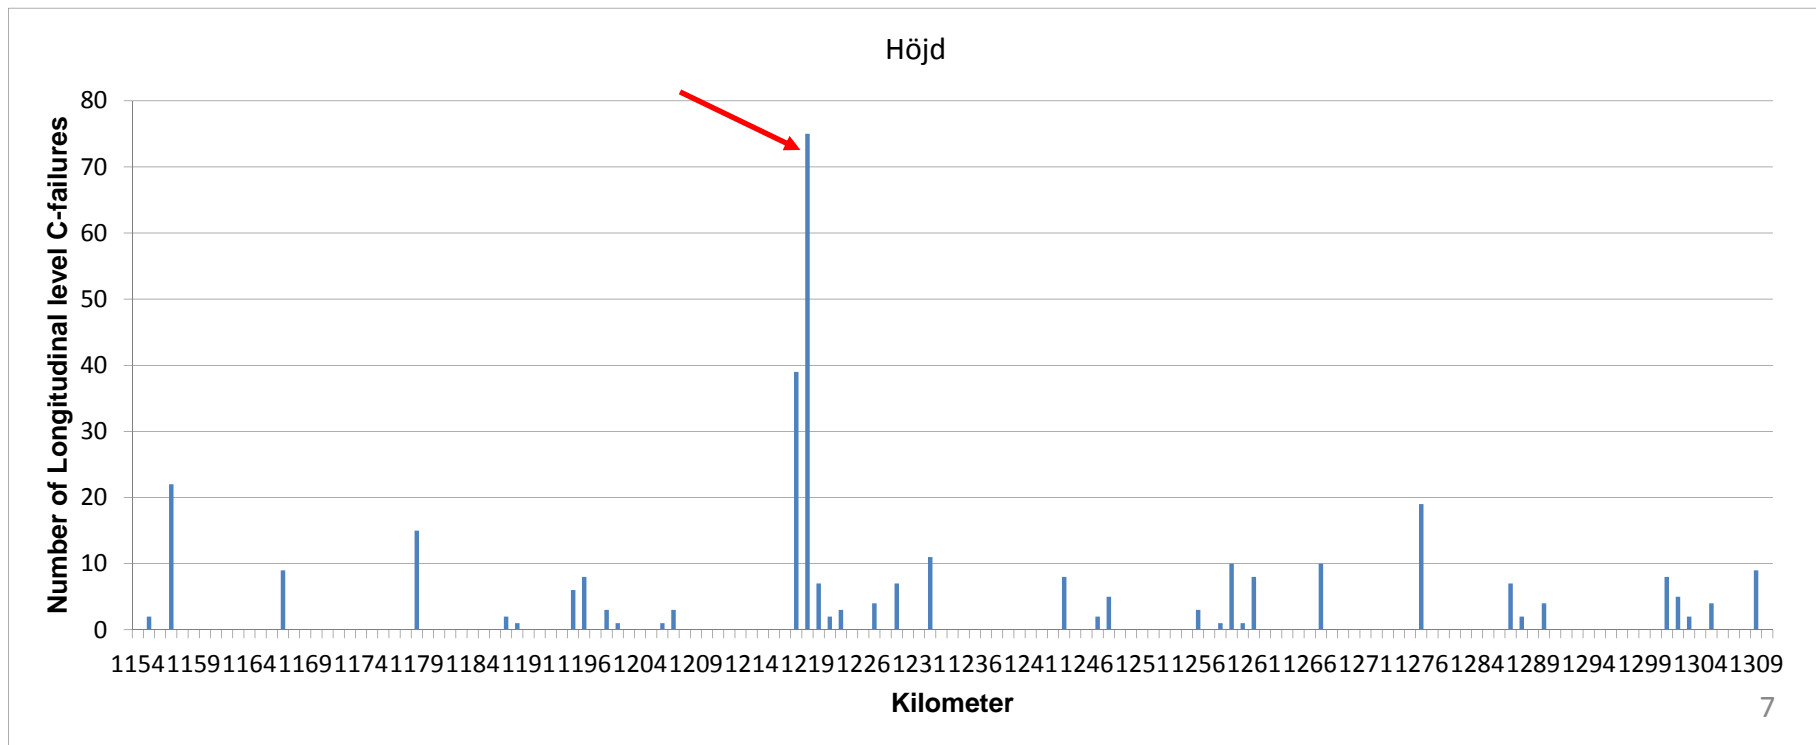
- Total number of detected longitudinal level C-faults on each 1000m track segment between 2004 and 2010
- Collected from inspection database (STRIX)

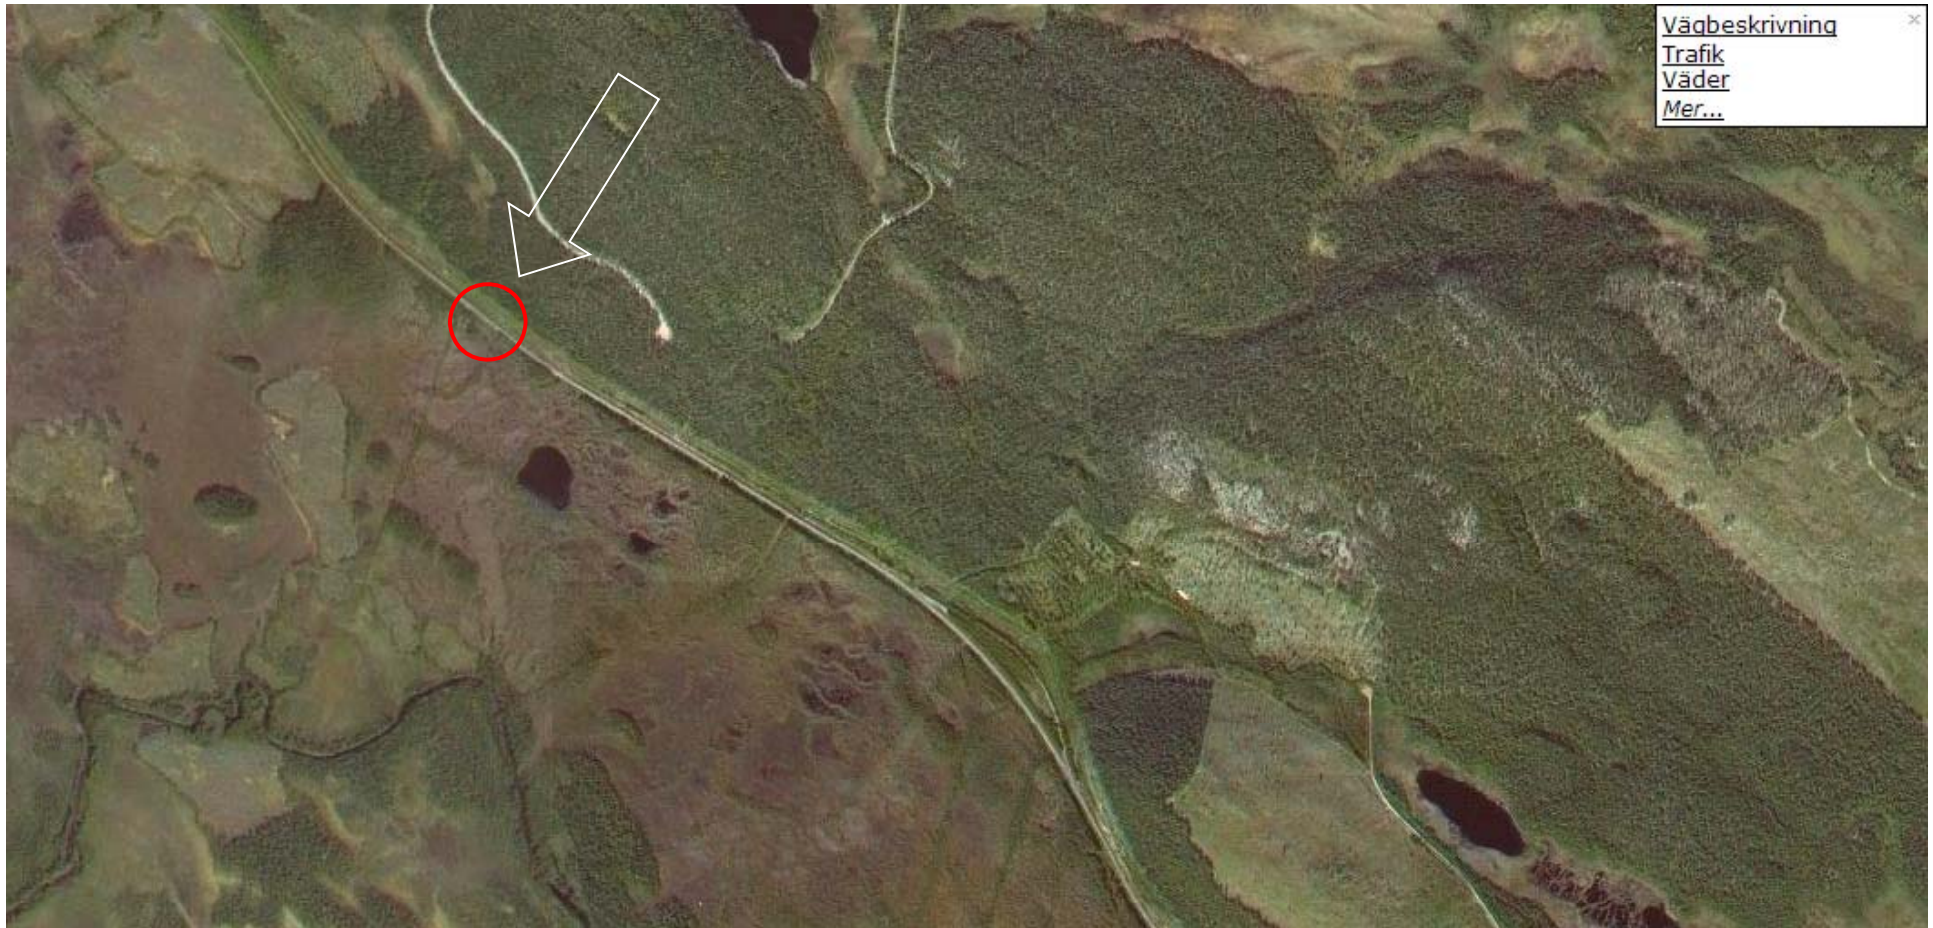
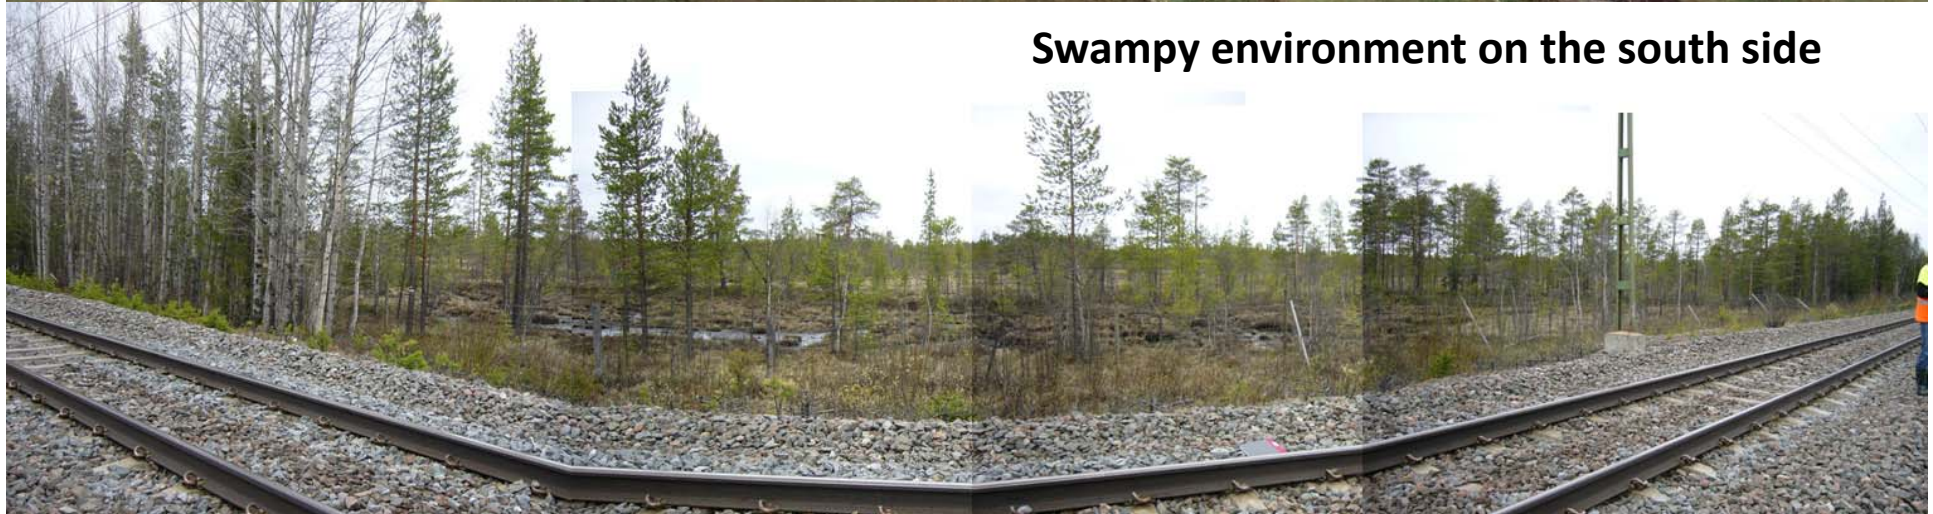
Swampy environment on the south side

- The effect of poor drainage

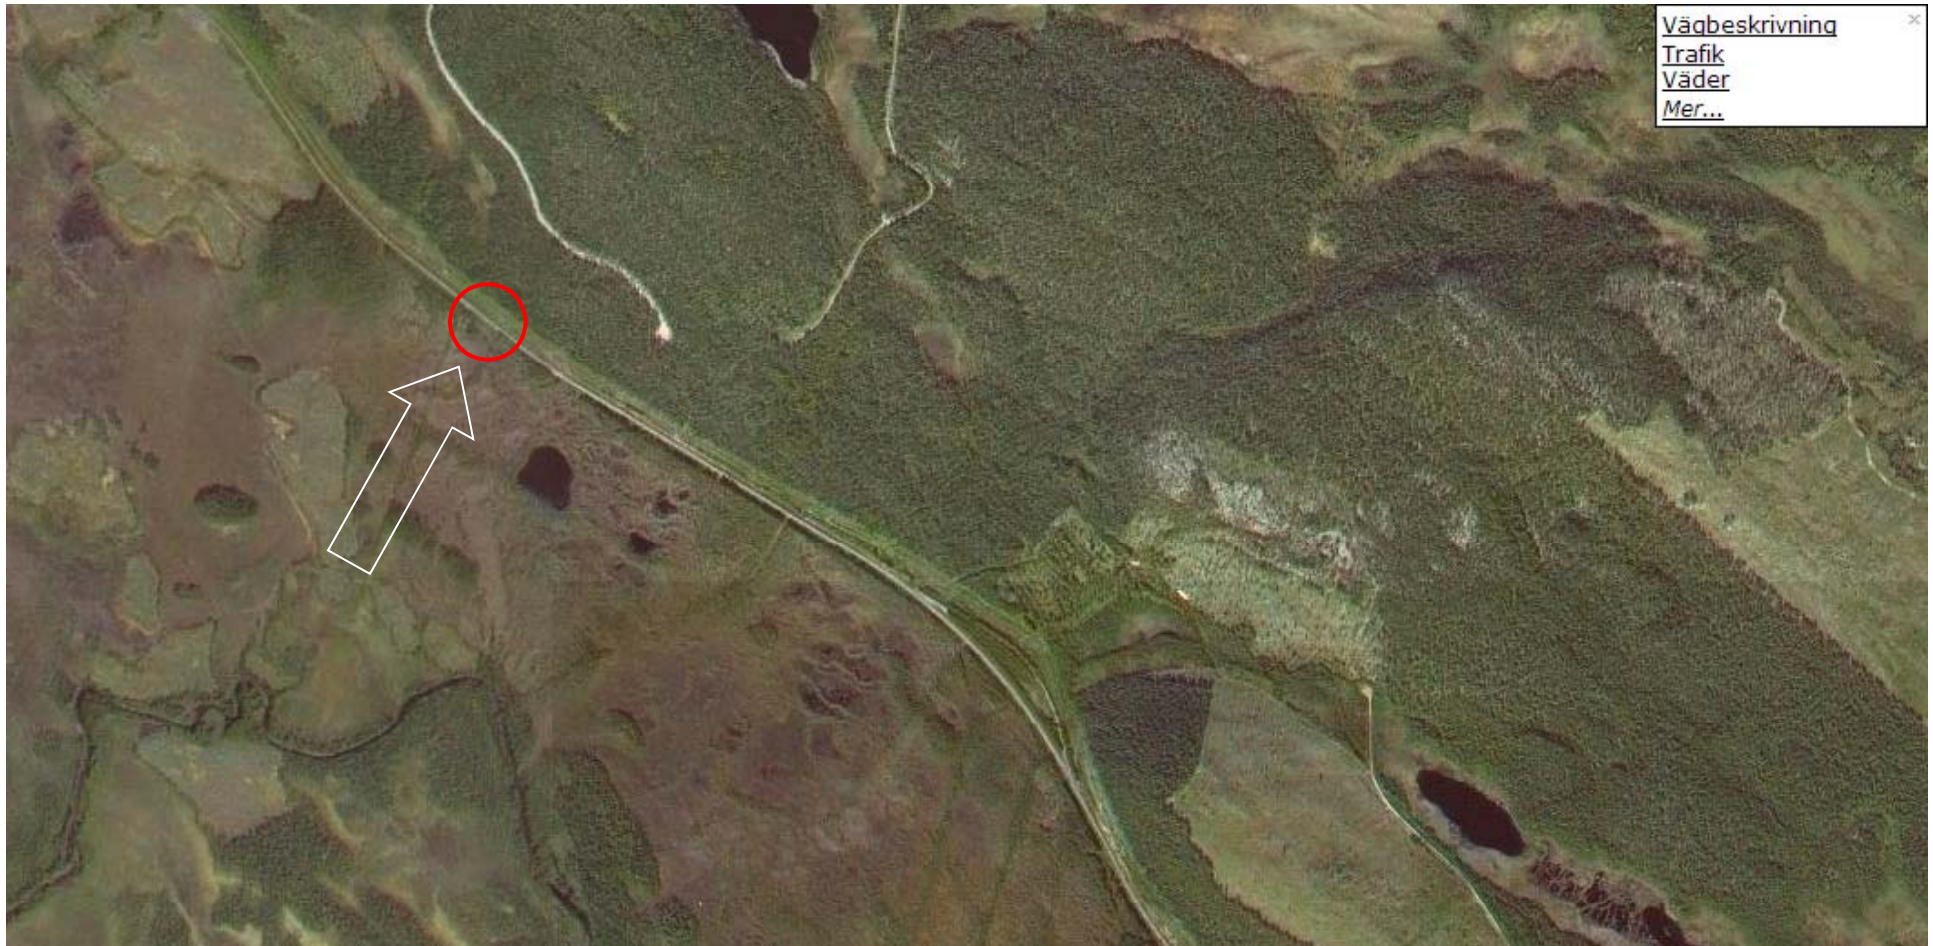
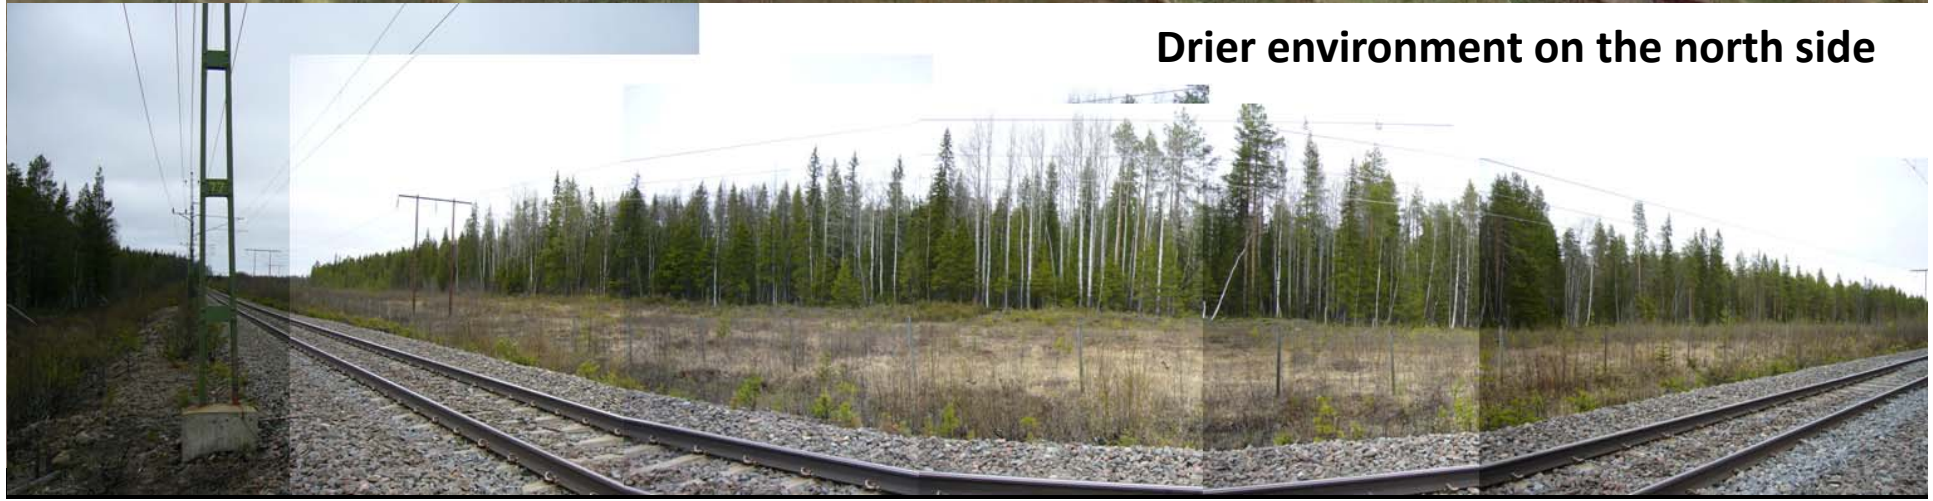
Drier environment on the north side

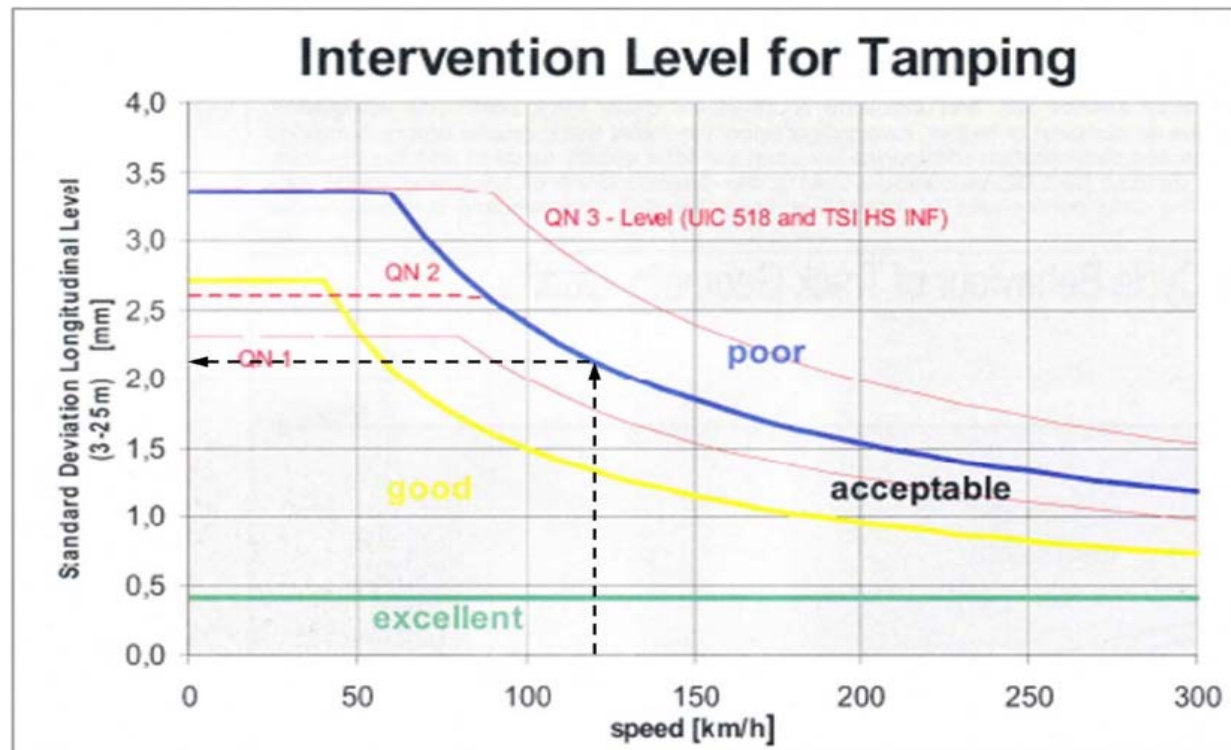
- Probability density function of tamping execution
UIC. Best Practice Guide for Optimum
- Between 2007 and 2009
Track Geometry Durability
- 200 m tangent segments

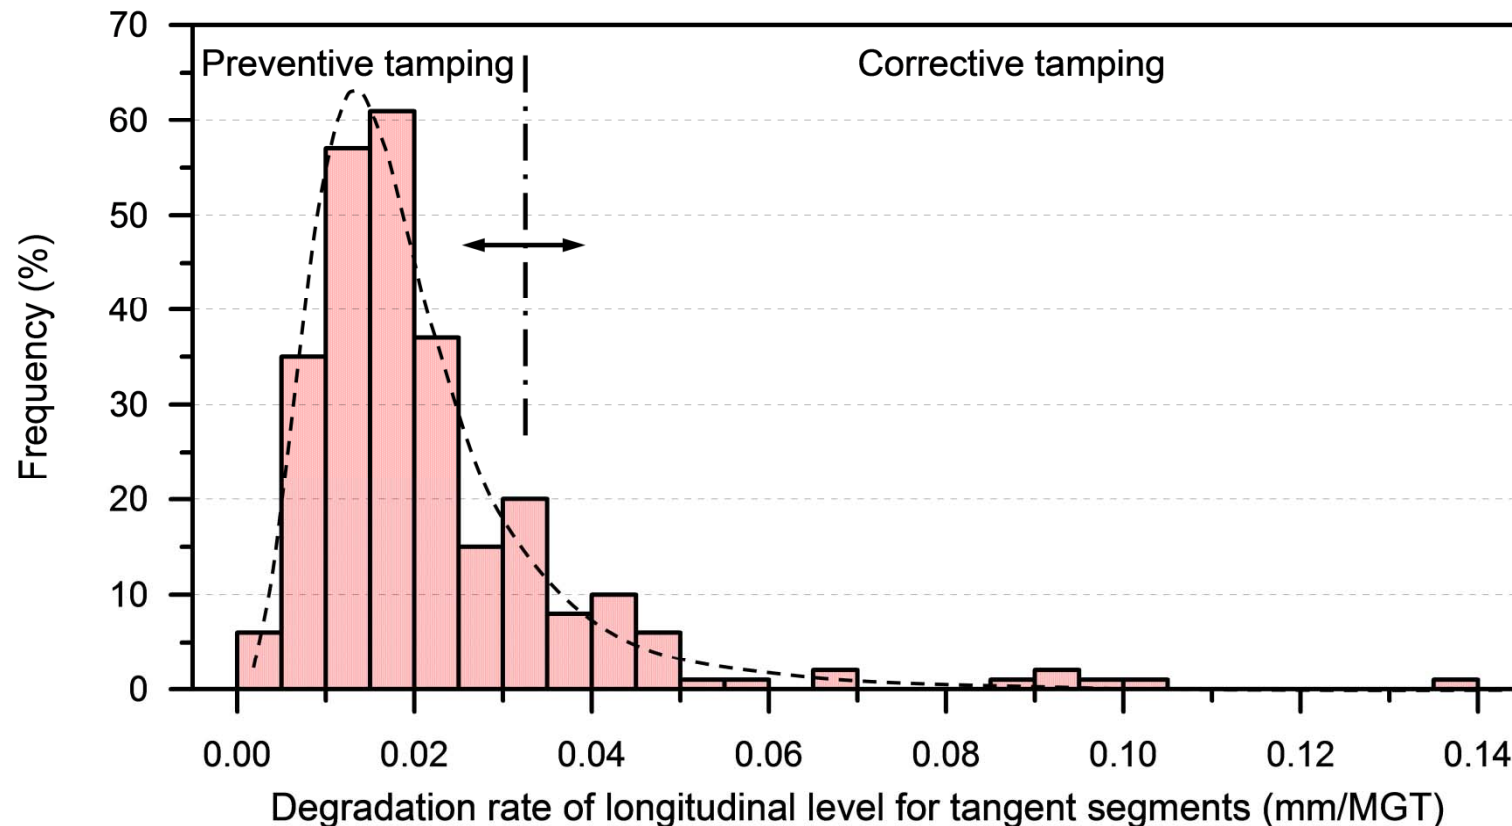
- Degradation rates of longitudinal level for 200m tangent segments (mm/MGT)
- Between 2007 and 2009

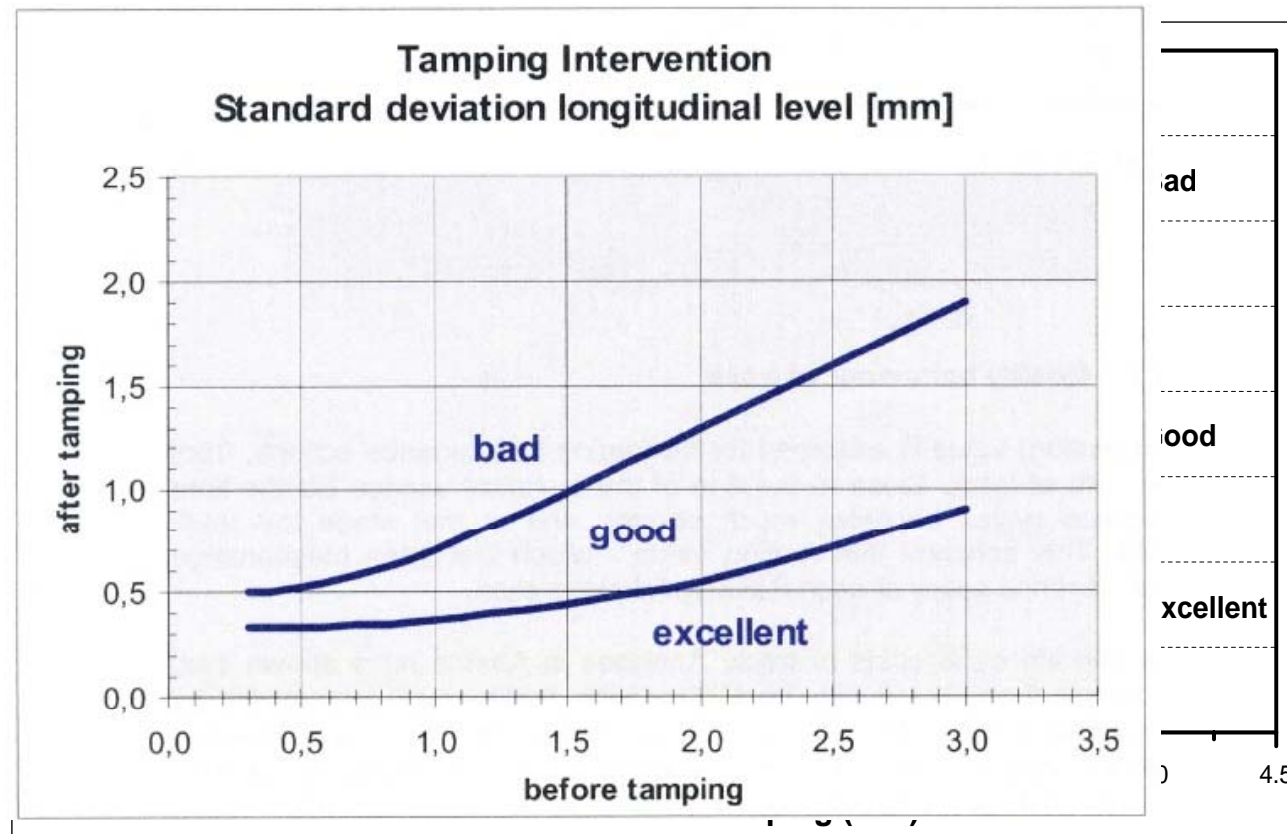
- Tamping efficiency on 200m tangent segments
UIC. Best Practice Guide for Optimum
- Between 2007 and 2009
Track Geometry Durability
