RAILWAY OPERATIONS IN SWEDEN AND JAPAN

Similarities and differences with a particular focus
on wheel/rail deterioration

MOTOHIDE MATSUI^{1,2}, ANDERS EKBERG¹ & ROGER LUNDÉN¹

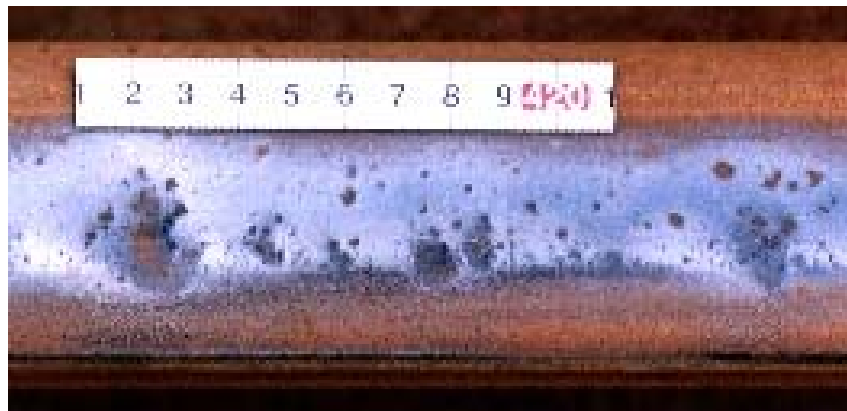
Multiple squats

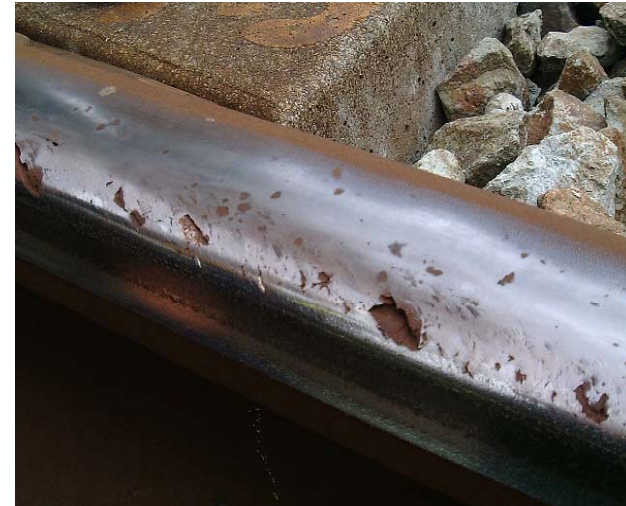
Head check & Flaking
(curve rail)

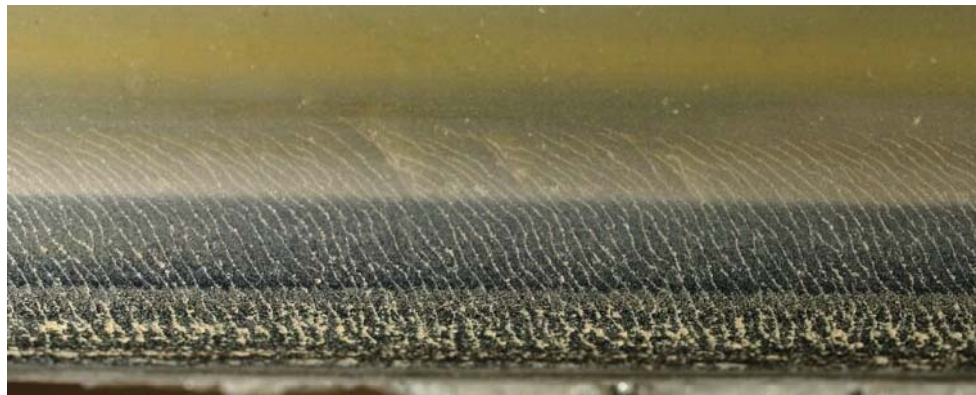
Head check (curve rail)

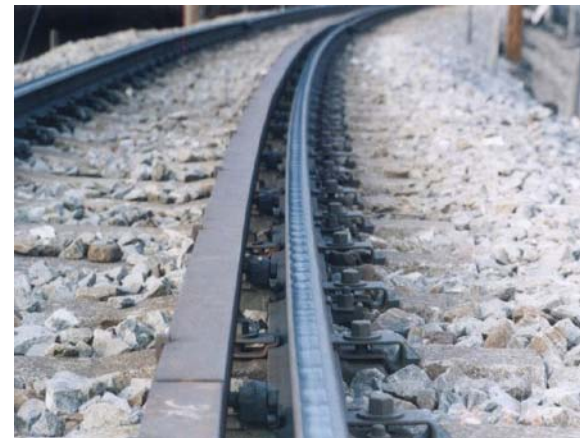
Corrugation (low rail)

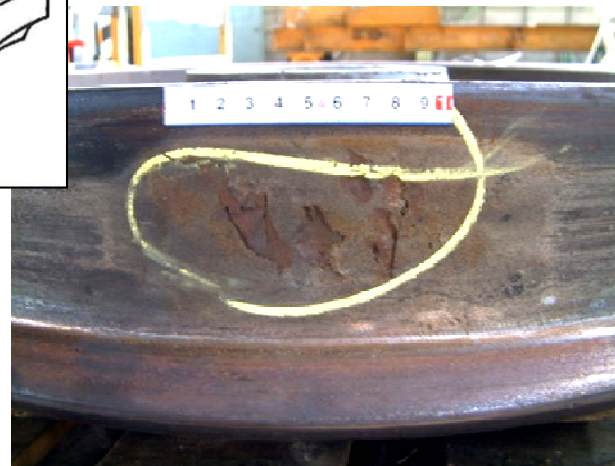
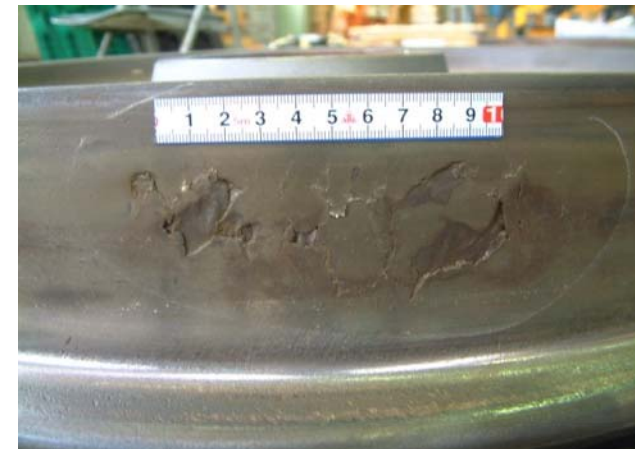
Typical wheel damage of freight wagon

Flat and flange wear were dominant (flat is rare now).
Hollow wear and thermal cracks are common
(not very detrimental).

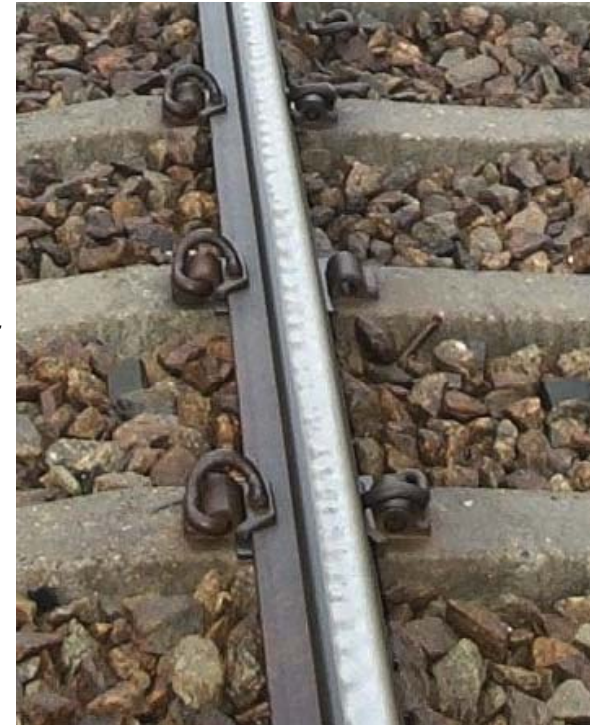
Rail corrugation
Photo Lennart Lundfeldt, Banverket

- Periodic wear (corrugation /out-of-roundness)
 - noise
 - risk of RCF

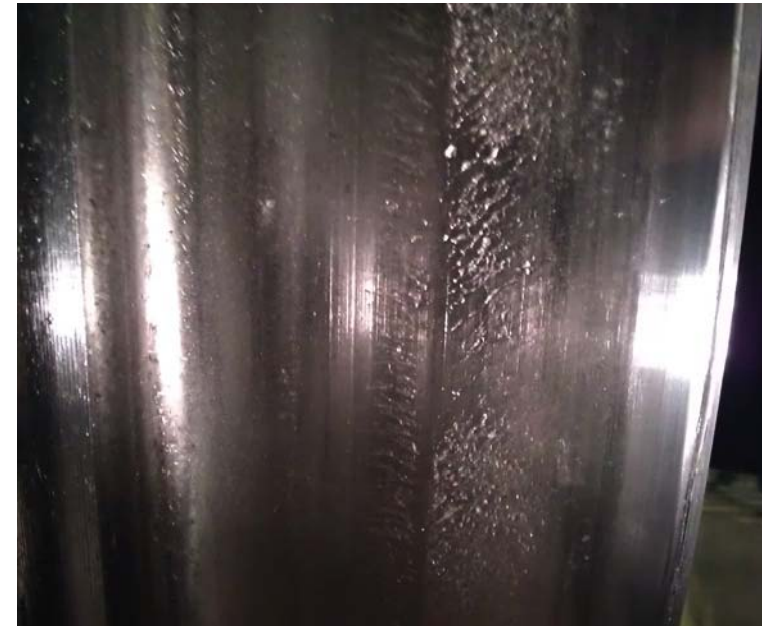
- Distributed RCF defects (head checks and wheel RCF)
 - curving and braking/acceleration
 - typically surface pits on wheels
 - risk of rail breaks

RCF-pattern of a Swedish heavy haul wheel

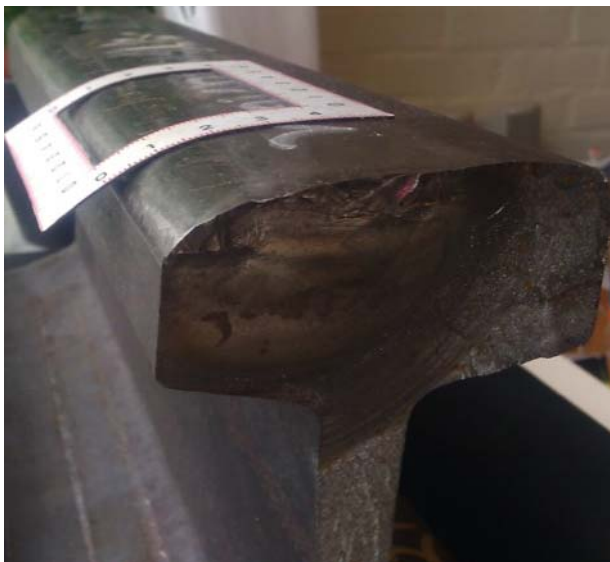
Rail break setting out from a headcheck crack
