Optimal Edge Beam System

International study

Adebowale Fasheyi

Stockholm 2013

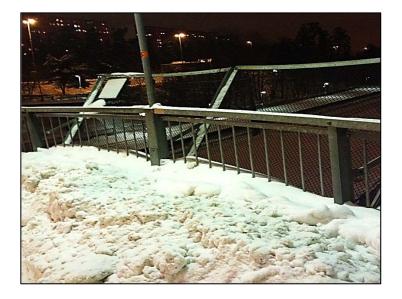
Figure 1.5: Snow pile contaminated with de-icing salt on the BEBS causing chemical attack on concrete and reinforcements

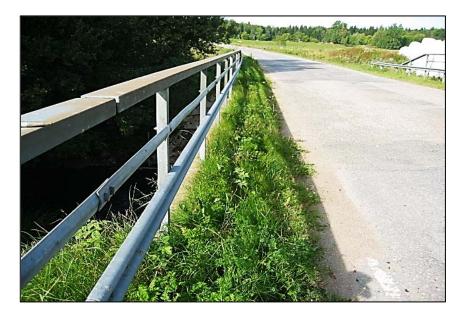
Figure 1.6: Vegetation growth that subsequently aids biological attacks on the BEBS Source: Johan Silfwerbrand

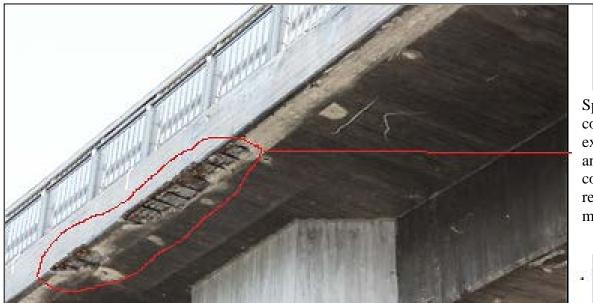
Spalled concrete, exposed and corroded reinforce ment

Figure 1.8: Degradation

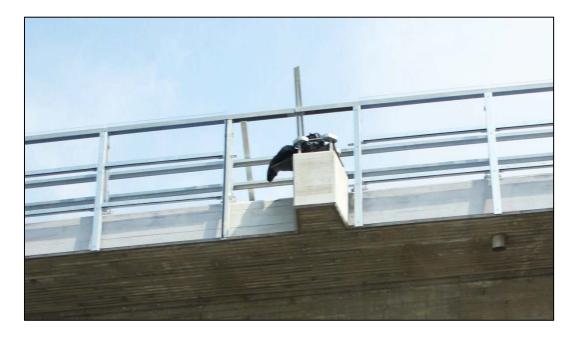
Figure 1.10: Cladding the edge beam with glass. A probable solution

- Appropriate design to allow edge beam systems to be self-resistant and safe in the performance
 - Cladding the edge beam with aluminum, glass and other available products. The figure below shows a typical example
